Access Elections! – Wisconsin’s Polling Place Accessibility Data Collection System

State of Wisconsin

SUBJECT: Access Elections! - Wisconsin's Polling Place Accessibility Data Collection System

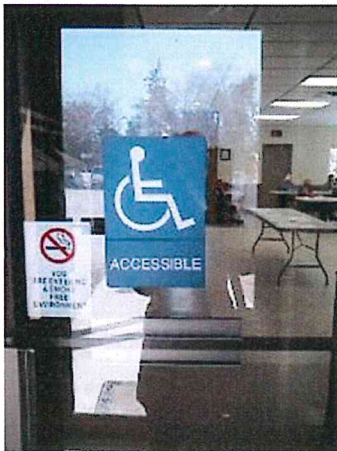
(figure 1)

Accessible entrances can be identified using a window decal or sign like the examples found below (figures 1 and 2). If a municipality does not own the facility where a polling place is located, a reusable or temporary sign can be displayed for Election Day.
